# First UK field application and performance of microcapsule-based self-healing concrete

Abir Al-Tabbaa<sup>a</sup>, Chrysoula Litina<sup>\*a</sup>, Petros Giannaros<sup>a1</sup>, Antonios Kanellopoulos<sup>a2</sup> and Livia Souza<sup>a</sup>

## Abstract

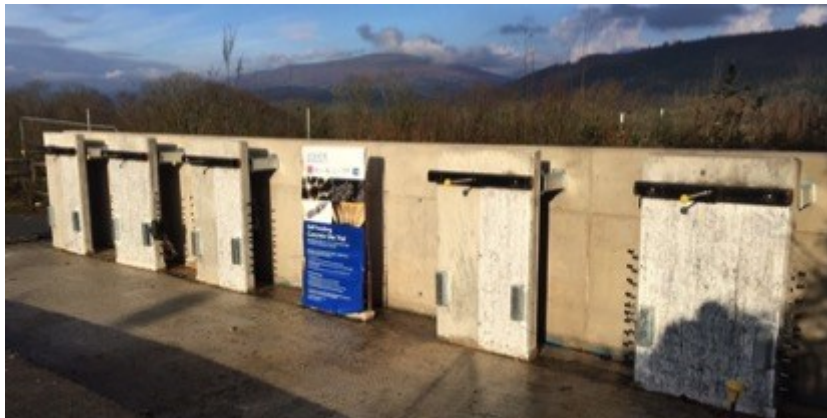
**Figure 3 Self-healing concrete wall panels constructed within the EPSRC and industry funded Materials for Life (M4L) project [35].**

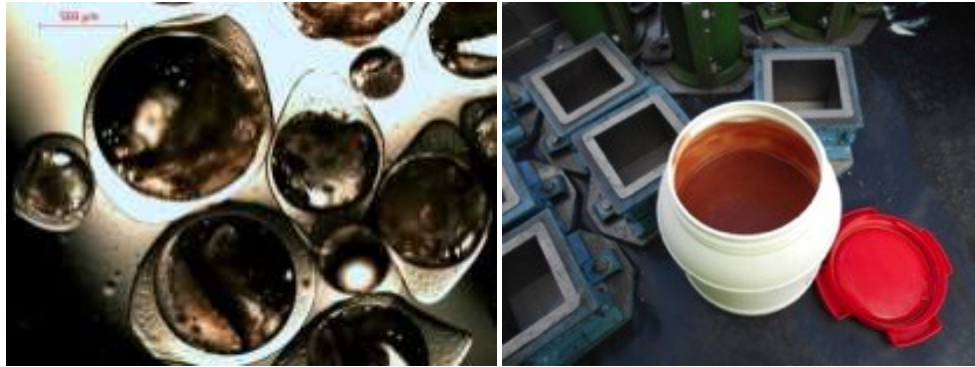
**Figure 4 The microcapsules used in the field trials; (a) the microcapsules under the microscope [19] and (b) microcapsule slurry as delivered to site [35].**

The microcapsules used here were the result of industrial collaboration, which led to the design and production, using complex coacervation, of gelatin/gum Arabic shell microcapsules containing sodium silicate (SS) as the cargo [19]. The sodium silicate was in an emulsion with mineral oil and emulsifier and formed ~42% of the cargo. The microcapsules (seen in Fig. 4a) had a mean diameter of 290 $\mu$ m with a standard deviation of ~120 $\mu$ m and were provided in a preserving solution (Fig. 4b). The microcapsules had switchable mechanical properties such that they initially had ductile ‘rubbery’ behaviour, which guaranteed their survivability during concrete mixing, and then became brittle, and easy to fracture, in the set concrete as water was removed from the shell [19]. Based on the results from related laboratory studies on the effect of the microcapsules on the fresh and hardened material properties and healing potential of mortars [21] and concrete [36], 8% microcapsule content by volume of cement ( $v_i$ ) was selected for application in the field trials. This dosage was found to provide an optimum level of healing, showed high compatibility with the mortar matrix and had negligible effects on the workability, setting time and strength development.

The concrete mix composition is detailed in Table 1. The microcapsules were first washed with water and filtered from their preserving solution before being added, in their slurry form, directly into the ready-mix C40/50 concrete using a portable 120L Belle concrete mixer. The microcapsules were added at 8% by volume of the cement, corresponding to ~2.67% by weight of the cement and ~0.47% of the total concrete mix. A small quantity of water was used to wash out the microcapsules from the container and as a result the effective water-to-cement (w/c) ratio of the concrete mix increased from ~0.43 to ~0.45. A control panel was also cast without any microcapsules.

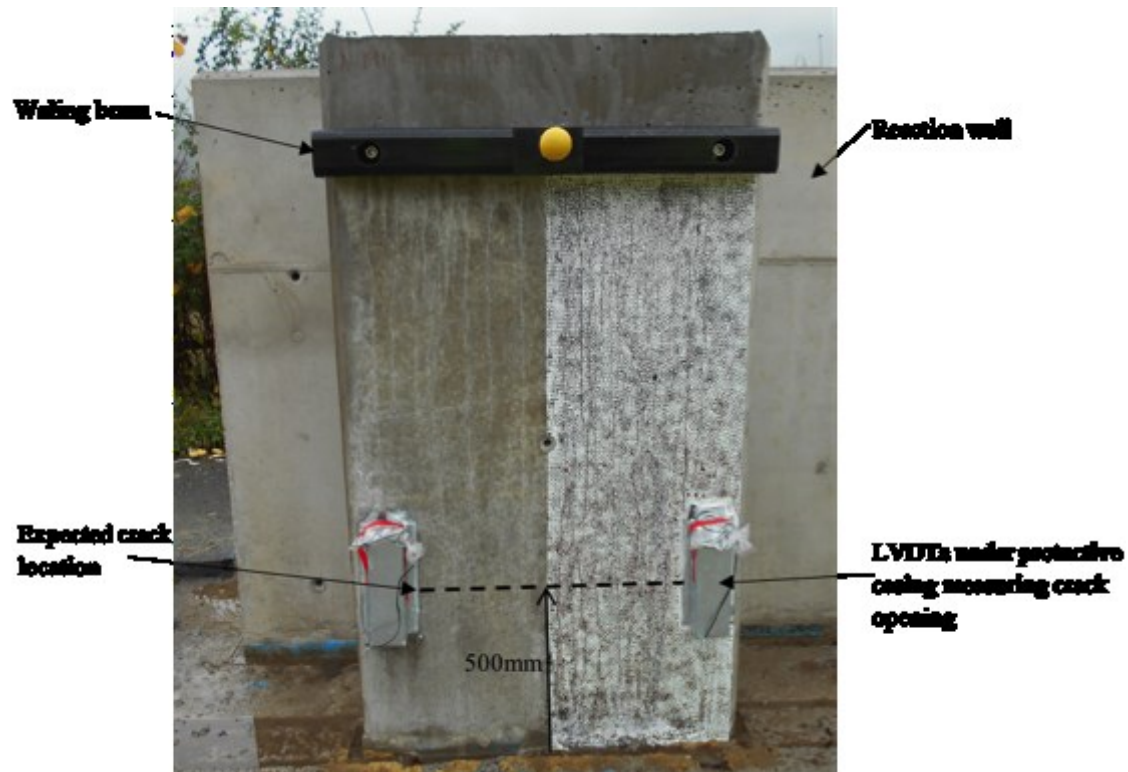
Figure 6 The microcapsule wall panel half painted with a black-and-white speckle pattern for DIC analysis

The wall panels were designed to crack 500mm from the base upon loading, which was facilitated by using 16mm diameter starter bars on the front face up to the designed crack location, before changing to the 10mm diameter mesh to create a weak section in the panel as seen in Fig. 5. Loading was applied using a hydraulic jack positioned 1.5m above the base of the panels, i.e. near the top of the wall, that was used to pull a threaded bar; thereby inducing a cantilever load. A wailing beam attached to the front of the panel allowed a distribution of load across the width of the wall. Full details of the design and construction of the walls is given elsewhere [35]. Panels were painted with a black-and-white speckle pattern for digital image correlation (DIC) analysis to monitor wall displacements and associated strains that arise during loading and unloading (Fig. 6).

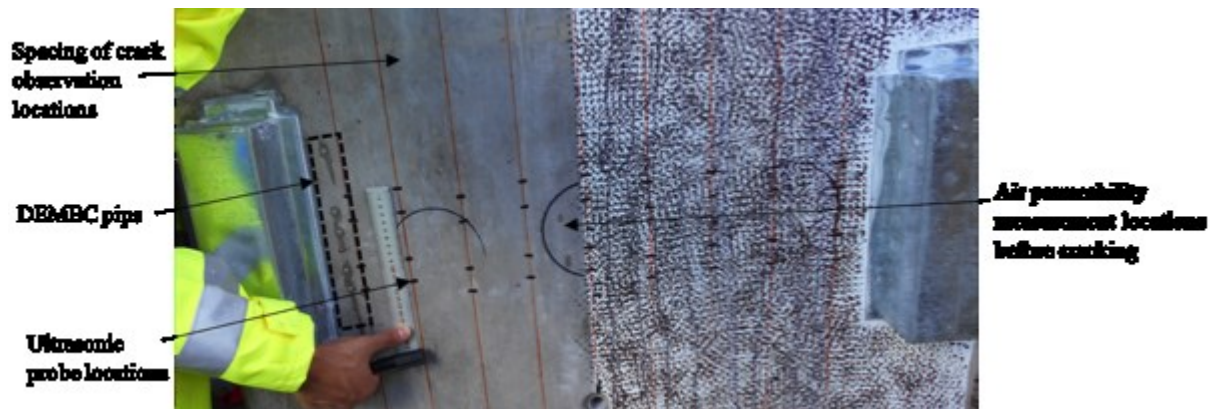
Figure 9 Location of DEMEC pips, ultrasonic probe measurement locations and air permeability measurement locations.

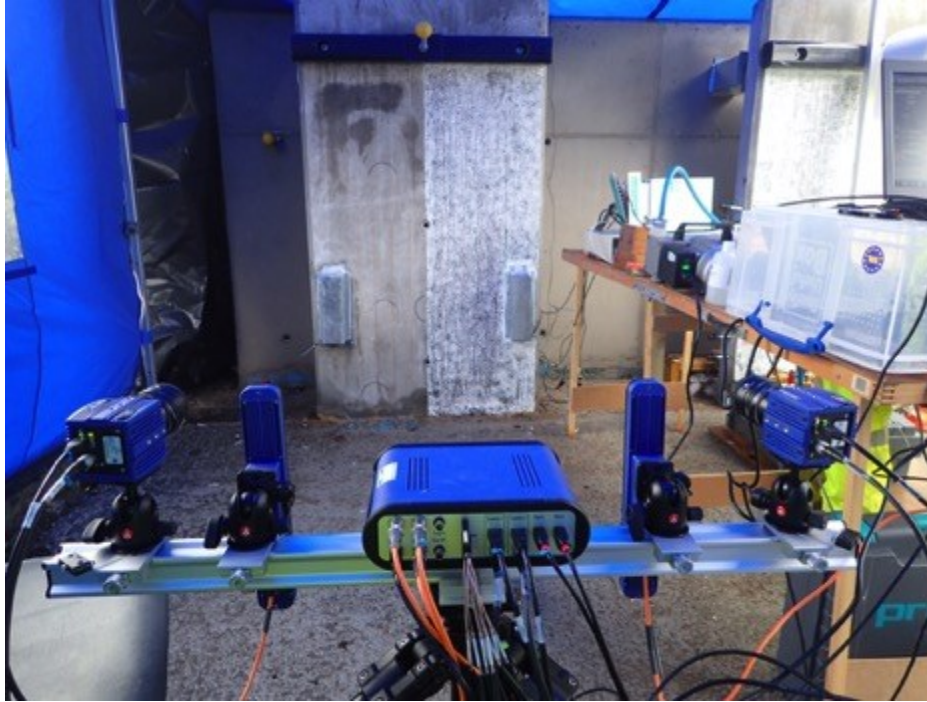
**Figure 10 Digital Image Correlation camera and tripod set-up on the microcapsule wall.**

The DIC software measured displacements through the comparison of images to monitor movement in the speckle pattern. Photographs of the wall were taken at each kN load applied (or released) using two digital cameras and flash equipment set up on a tripod facing the wall panel (Fig. 10). The use of DIC allowed monitoring of crack initiation, coalescence and propagation. The covering of one-half of the wall face only in the speckle pattern offset any potential variations in obtained measurements due to the hydrophobic/water repellent nature of the paint. After initial cracking, a strip of thermal insulation foil roll was placed across the middle section the microcapsule wall to reduce its exposure to the environment. This was to examine the effect of sealing on the overall healing progress for both halves of the wall although the insulation was permanently removed after
